Subject: Proton Improvement Plan

Project Quarterly Summary FY13 Q2

Report #4 Apr 01, 2013

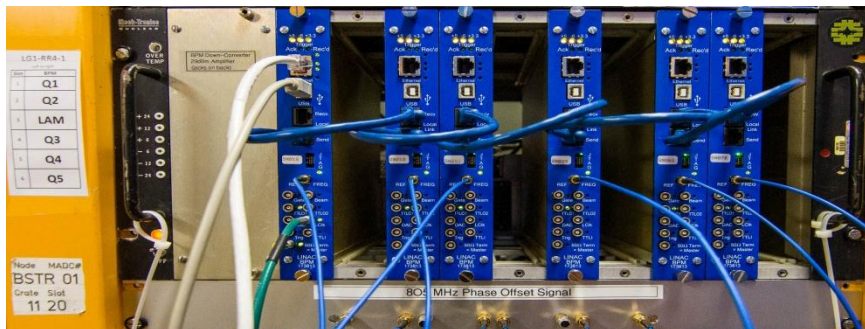
Figure 1 A new Linac digital BPM crate

Complete installation and commissioning of the new BPM readout modules. A total of 66 modules were installed and beam commissioning was performed over the course of this quarter. Various problems were encountered and addressed. Some were simple problems such as forgetting to save registers, loose connections and NIM power supply failure. A more difficult problem is the 805 MHz input signal. When the input signal goes away, the FPGA enters into an undefined state and the crate needs to be rebooted. This occurrence is more severe at the 400 MeV region which receives the reference frequency from a different location compared to the Linac BPM crates. A work around has been developed by the design engineer by the end of this quarter. Nevertheless, the Linac BPM module upgrade is complete.

This fulfills a Level 3 milestone on time and marks the first Linac WBS Level 3 completion within PIP.

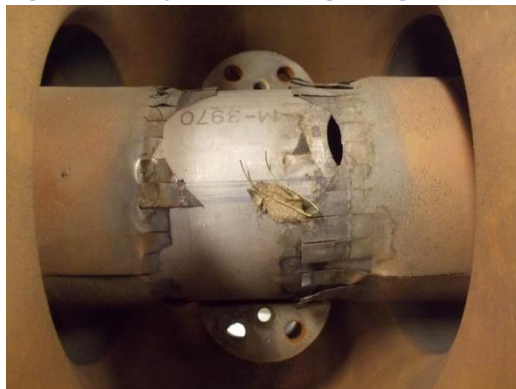
Figure 2 A cavity tuner - showing RF fingers

The refurbishment of the fifth cavity tuner set was done during this quarter. The time it takes to

refurbish and test each set has decreased with the average of the last three sets taking a little more than ten weeks. With each refurbishment, we are learning how to make the process better.

However, the second cavity tuner set has developed an RF leak. This will require the set to be removed from service, investigation of the RF leak, taking the set apart, fixing the problem and then reassembling followed by certification. Preliminary in-situ investigation points to the outer flange

between a tuner and cavity not being a good RF connection. While the set is apart, the inner flange will be reworked (same as the most recent refurbishments). This additional reworking of the second cavity tuner set requires that refurbishment of the current cavity tuner set be interrupted for two to four weeks. There are indications that the first cavity tuner set refurbished may also have a small RF leak.

During a recent refurbishment, the outer flanges were identified as possible problems. The refurbishment procedure has been amended to check-out/rework these flanges whereas before the

flange was inspect and only worked upon if the cavity tuner set could not be certified at high gradient at 15 Hz.

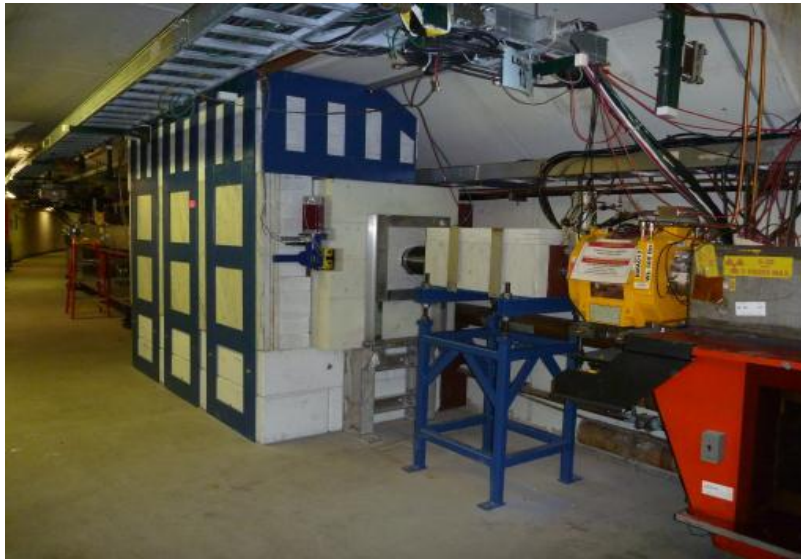
Figure 3 Booster Absorber system installed

All work associated with the notcher absorber in the tunnel was completed early this quarter. The system has been roughly timed in and will be fully commissioned in the third quarter. Procurement of parts for upgraded notcher kickers and associated power systems continues.
